Trus Joist® TJI® Joist Repair Details for Holes Located Within 12" of End Bearing

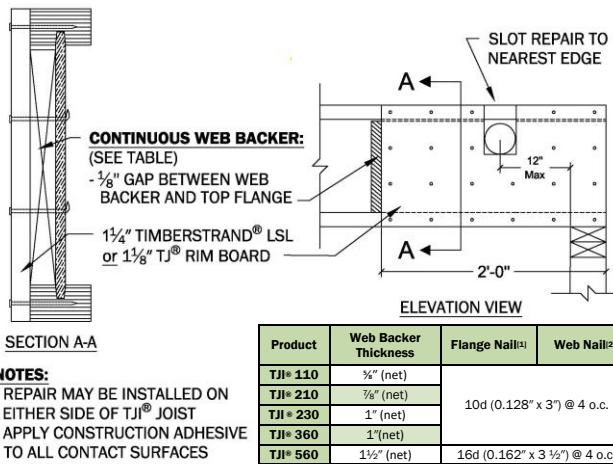
Figure 1: Repair detail for holes located within 12" of end bearing.

To ensure optimal performance of TJI® joists, web holes in TJI® joists should be positioned away from support locations in accordance with Weyerhaeuser literature. The table and detail below show how to repair a TJI® joist with a hole located within 12" of an end bearing and the maximum hole diameter allowed in these cases. This repair option assumes typical residential floor framing situations and is allowed **ONLY if the joist is repaired as shown and does not exceed the maximum span, o.c. spacing, and loads given by Table 1.**

- [1] Span table and Figure 1 apply only to holes located within the first 12" of the joist end bearing. They DO NOT apply to holes located closer to intermediate bearings than allowed in Table B of TJI® Joist Specifier's Guide ([TJ-4000](#)).
- [2] Hole shall NOT overlap inside face of bearing, and no other holes shall be cut inside or within 6" of the repaired area. See DO NOT details below.
- [3] For 12" o.c. spacing, use 16" maximum; for 19.2" o.c., use 24" maximum.

- **Install headers on either side of the TJI® joist.**
Reference Engineered Wood Products Header-off Span Tables in technical bulletin [TB-319](#) for maximum allowable spans.
- **Replace the joist or add a new joist beside it.**
 - TJI® joists spaced at 24" o.c. may require an additional TJI® joist on each side of the damaged joist to ensure sheathing span limit requirements are met.
 - Use Weyerhaeuser literature to verify the allowable joist span when adding a new simple span beside a damaged, continuous span joist.
- **Analyze joist with Weyerhaeuser design software.**
Web hole may be permitted based on hole provisions specific to [ForteWEB®](#).
- **Contact your Weyerhaeuser representative to request a detailed hole analysis.**
